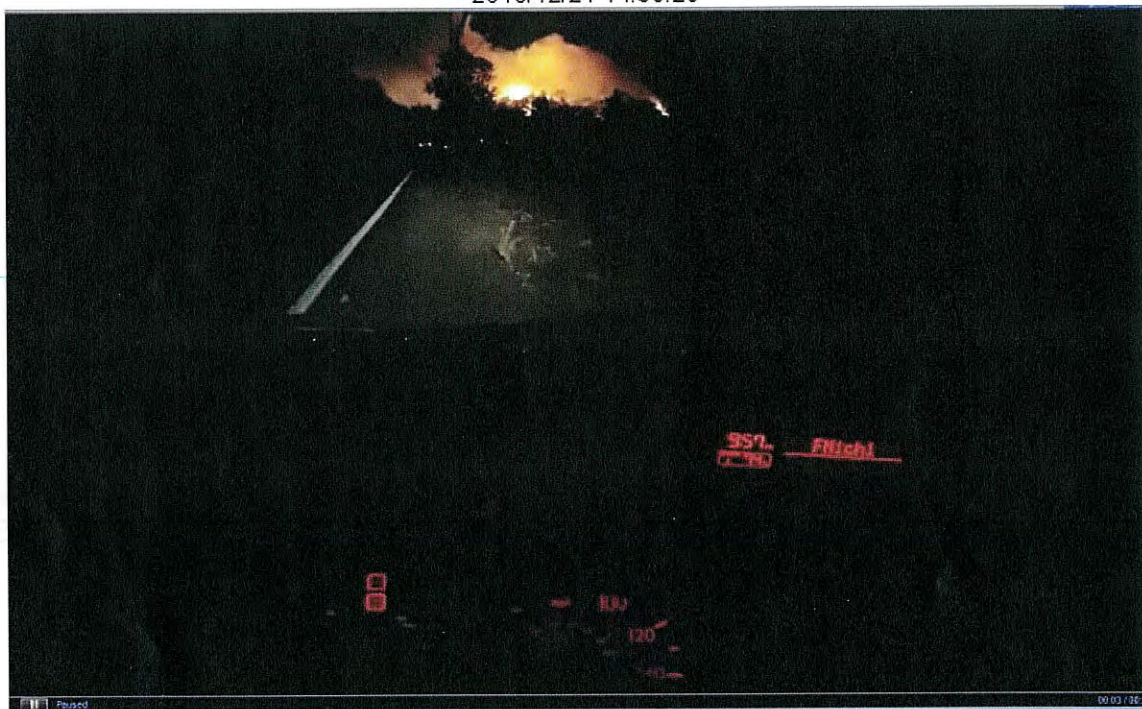
COLE_video_screenshot.JPG
- 2018/12/21 14:39:25

> record time was 2145 hrs.
>
> This video was recorded along Hwy 128 just north of Tubbs Lane: coordinates 38.594250 x -122.614211.
>
>
>
> Also, regard the security video recorded from the winery, coordinates 38.600101 x -122.615087, which I believe you have in evidence- are you aware of the arc flash that lasted for approx 1/10 second?
>
>
>
> Mike [REDACTED]
>
>
>
>
>
>
> Begin forwarded message:
>
>
>
> From: Mike Cole <[REDACTED]>
>
> Subject: Tubbs video
>
> Date: October 12, 2018 at 8:31:17 AM PDT
>
> To: Cole Mike <[REDACTED]>
>
>
>
>
>
>
>
